# SAVA Technical Bulletin

Issue 17 | February 2014

## Condensation in solid wall houses

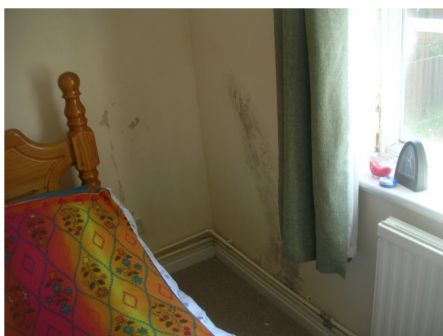
The damage to the interior was extensive. The right hand corner of the house (Photos 1 & 2) was affected by extensive mould growth to the interior surface of the reception room (now used as a bedroom by one of the tenants).

**Photo 1:** The right hand corner of the house showing extensive mould growth

Invasive investigation was conducted at this point by drilling two holes in the wall around 1.5 metres above the internal floor level and inserting deep probes attached to a moisture meter. This confirmed a high level of moisture in the deep wall in addition to that also recorded on the surface of the wall. This would typically indicate that the wall here was affected by penetrating damp. Black mould growth was also extensively growing on the wall surface. Such growth is more typically associated with condensation as mould will not grow where water is contaminated by the salts typically found in moisture from penetrating and rising dampness.

There are various measures that can be installed to reduce condensation in this house, but the key measure is the repair of the external render. The issue of penetrating damp to the walls must firstly be resolved. It would also be prudent to improve the balance of insulation to the dwelling by providing some form of insulation to the walls to prevent the promotion of condensation.

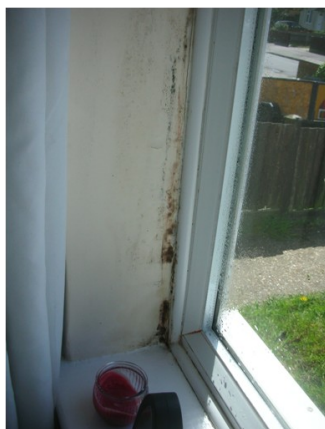
Damp was also recorded with the aid of the moisture meter around the front window of the same room (Photo 2).

**Photo 2 :** Front window of the same room (Photo 1)

Black mould growth was also extensively growing on the wall surface, again more typically associated with pure water and therefore condensation related.

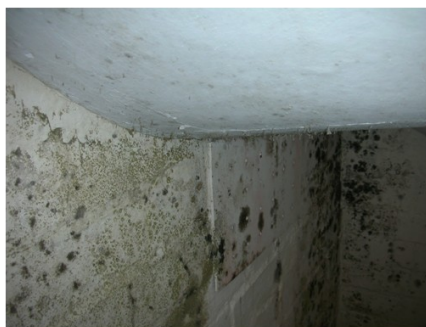
Substantial mould growth had also developed in the cupboard area under the stairs (Photo 3).

**Photo 3:** Mould growth in the cupboard under stairs

Readings taken with the moisture meter indicated high dampness in the corner and surrounding wall. This could possibly be due to penetrating dampness but also due to condensation in a part of the property that was not heated and was separated from the rest of the building, thus not benefiting from drift heat.

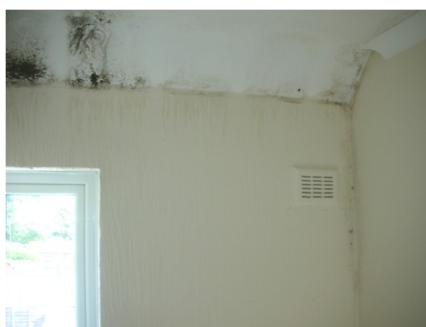
The staircase walls were also affected by extensive black mould growth (Photo 4). This also extended to the cupboard at the top of the stairs.

**Photo 4:** Mould growth on walls and ceiling of staircase

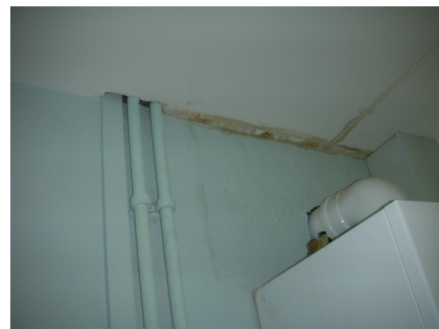
- ♦ There was a leak from the bathroom where water from the bath/shower was running down the wall, passed the shower screen, on to the bathroom floor (Photo 5). This in turn was causing damp stains and damage to the ceiling of the kitchen immediately over the new boiler.

**Photo 5:** Leak from bathroom

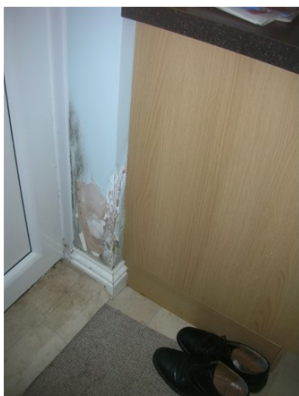
- ♦ There was also damp penetration around the back door near the location of the boiler but lower down the wall (Photo 6 over the page).

**Photo 6:** Damp penetration at base of back door

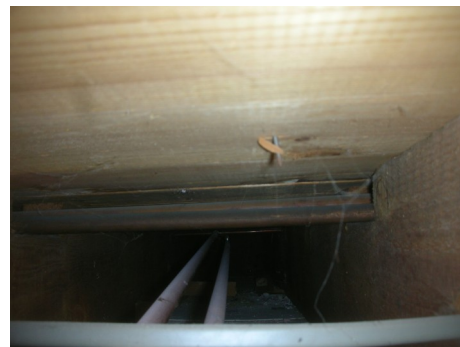
The original surveyor was instructed by the conveyancing solicitor to return to the property and undertake a further inspection of the floor void. The floor void between Nos. 40 and 41 was formed of timber floor joists with what appeared to be a single skin of plaster board to the ceiling of the room below (No. 40). Timber floor boards were secured to the upper side of the floor joists to provide the floor of the bedroom of No. 41. There was no fire stop material or fire break walling between the continuation of the floor void between Nos. 40 and 41 and this is a fire hazard (see Photo 3).

**Photo 3 :** There is no fire stop material or fire break walling between the continuation of the floor void between No. 40 and No. 41. This is a fire hazard.

After this second inspection the surveyor recommended that fire break provisions be made to the room to comply with current Building Regulations. A suitably qualified contractor should be instructed to quote for and undertake this work, and provide sufficient warranty or documentation that the work undertaken meets the current standard.

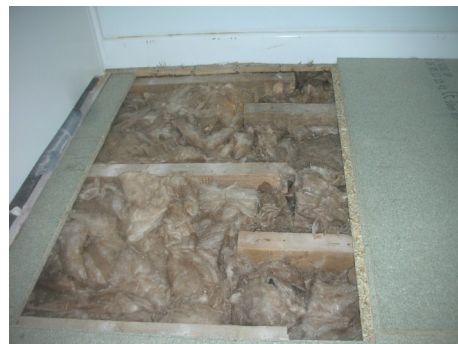
**Photo 4:** The matter of fire resistance to the floor void was resolved by providing fibre glass wool insulation between the floor joists to at least improve the fire resistance between the two properties.

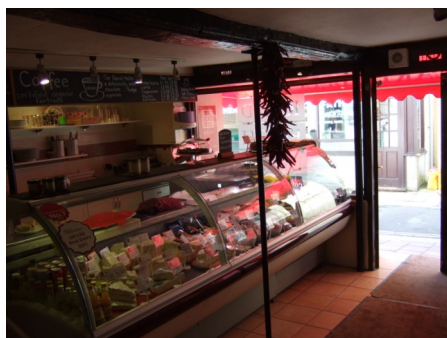
The surveyor went into the delicatessen below the living room and the photo below shows what he found.

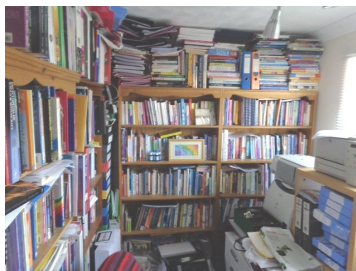
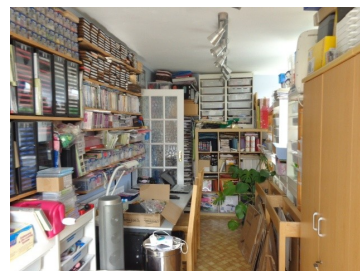
*"It was difficult to know where to start with this one....Nearly every room was like this, floor to ceiling furniture and shelving. Similar story in the roof space."*

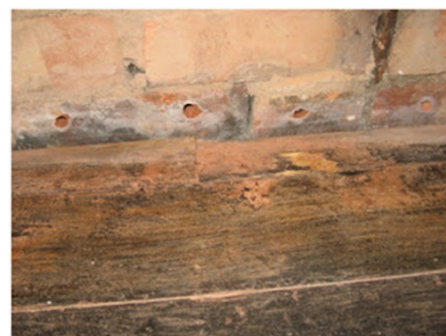
If it is installed above the timber floor joists then what good is it doing? This property had two courses of blue engineering bricks as DPC.
