# SAVA Technical Bulletin

Issue 17 | February 2014

## Condensation in solid wall houses

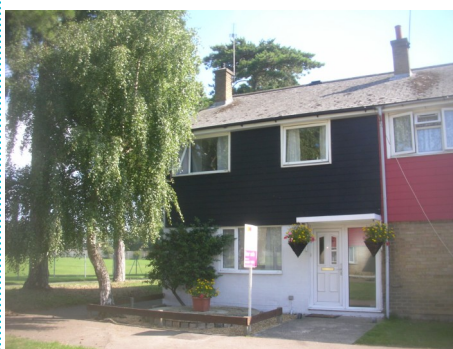
**Photo 2:** 1960s end terrace

Take the subject of this case study (Photo 2). It is a 1960s former council end-terraced house. It is built to two storeys in traditional brick masonry with a sloping roof. The Local Authority had owned it for at least two decades along with the other houses on the estate.

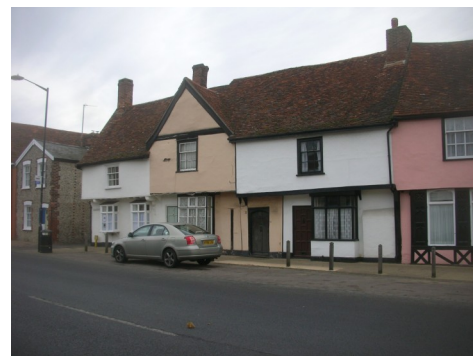
The trouble with flying freeholds is that they can be a legal complication that is not always that easy to spot. A flying freehold occurs when one property overlaps another and part of its boundaries are overlapping the adjoining property (known as the submerged freehold, Photo 1). Typically this kind of legal anomaly develops when two properties were previously owned by the same landowner and that land owner divided the building without regard for preserving a vertically clean boundary between the two properties created in the subdivision.

**Photo 1:** Look at the way these cottages are painted: the first cottage (left) in the row is white and the entrance door (partly obscured by the car) is below the first floor of the second cottage (middle-cream coloured). The entrance door of the second cottage is below the first floor of the third cottage (right-white). Each demonstrates an example of flying freeholds.

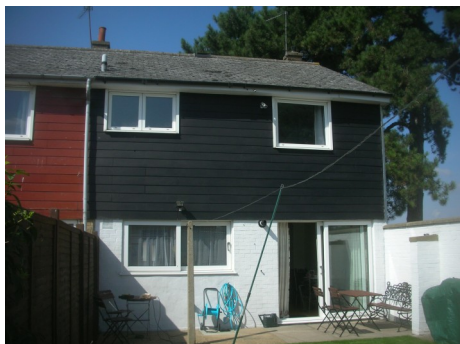
The bedroom window belonging to the flying freehold element is overlooking the garden of No. 40. The asbestos cement tile cladding to the exterior wall of that room is the same as the rest of No. 40 and a different colour (terracotta) completely to that applied to the rear elevation of No. 41 (charcoal) (Photo 2). It is only upon internal inspection that the anomaly is suddenly apparent.

**Photo 2:** Rear elevation of Numbers 40 (left) and 41.

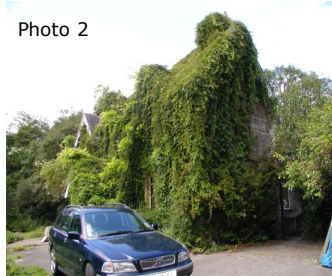
Photo 3

Jeff Parsons submitted the following entry of a house he inspected in rural Worcestershire. Parts of the roof and many of the walls and windows were hidden behind this creeper (Photo 1). The gable wall contained two stone mullion windows on the first floor (Photo 2) which were also hidden internally by cupboards (Photo 3).

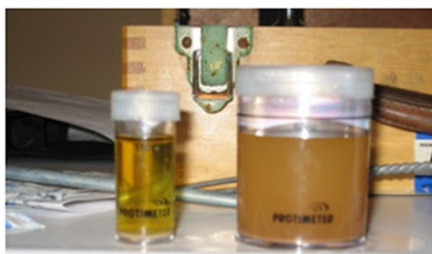
A Negative salts analysis in a property diagnosed as having rising damp.

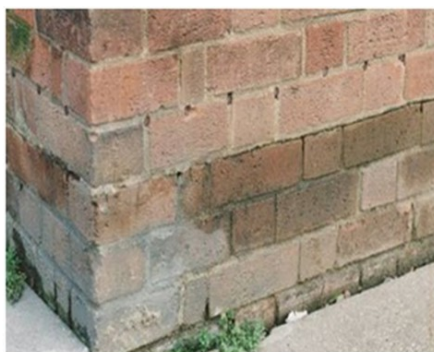
Presence of a functional physical DPC has not affected the retrofit DPC installers action; Source: [www.dampbuster.com](http://www.dampbuster.com) & [www.buildingpathology.com](http://www.buildingpathology.com).
